MINES BRANCH INVESTIGATION REPORT IR 64-3

FAILURE OF "BANJO" FITTINGS IN INFLATABLE LIFERAFTS

A. COUTURE

JANUARY 22, 1964

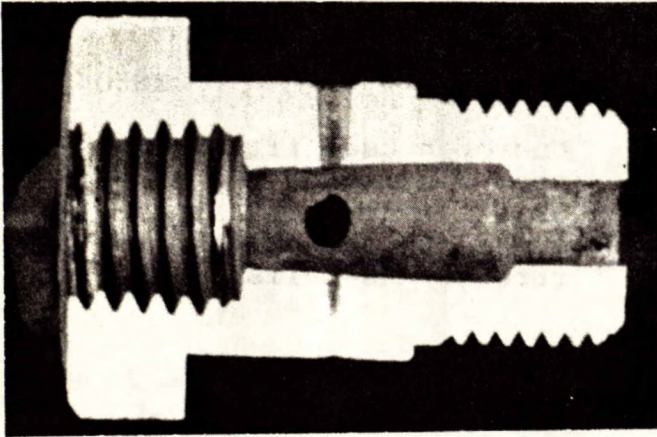
Figure 1

The fittings investigated appear as shown in Figure 1. CO₂ gas passes into the fittings through four 3/32 in. diameter holes and flows out into the buoyancy chambers through the smaller end (right hand side of Figure 1), which in this report shall be called the male end. An Allen screw plugs the female thread at the other end (left hand side of Figure 1).
