MINES BRANCH INVESTIGATION REPORT IR 64-88

**EXTRUSION DEFECTS ON 90/10 AND
70/30 COPPER-NICKEL TUBES**

E. WINKLER & J. A. PERRY

SEPTEMBER 20, 1964

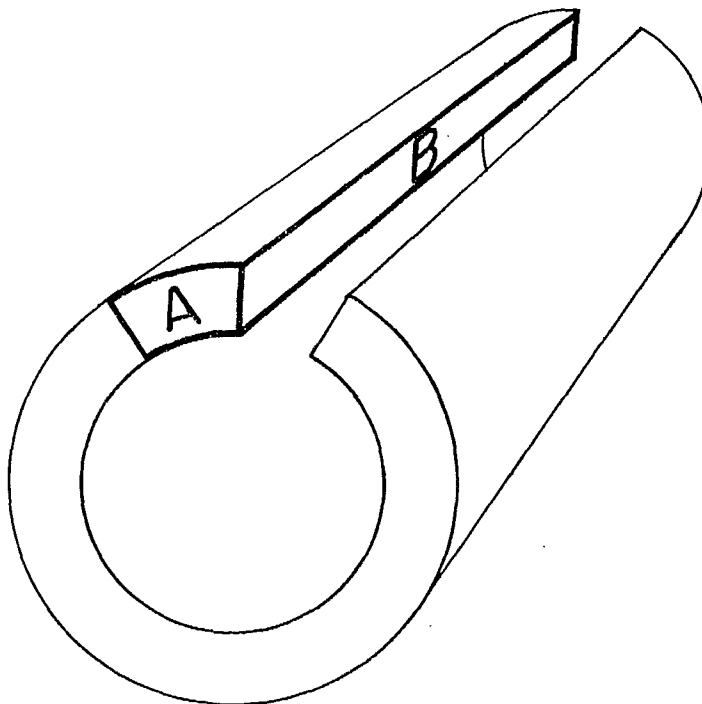
Samples of cracked specimens have been vacuum impregnated with a resin of low viscosity which penetrated the cracks. The specimens then were cut and polished in two perpendicular directions as shown in Figure 1. A and B represent the two perpendicular areas which have been polished.

Figure 1. Cross-sectional view of tube indicating where samples have been taken. A and B represent the polished sections.
