BURNING TRIAL ON SCHEDULE IV CONTAINER

E. Contestabile, R. Vandebeek and R. Augsten

July 1987

MINING RESEARCH LABORATORIES  
DIVISIONAL REPORT MRL 87-72 (TR)

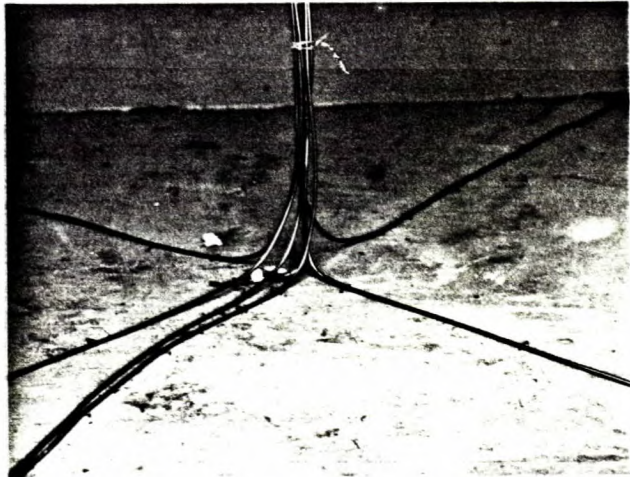
Figure 1 shows a bundle of thermocouples, with TC-2 terminating on the centre of the bottom panel, TC-5 and TC-6 leading to the door opening and TC-13, TC-14, TC-15 and TC-16 radiating to the bottom four corners.

1. Thermocouples on bottom panel of container

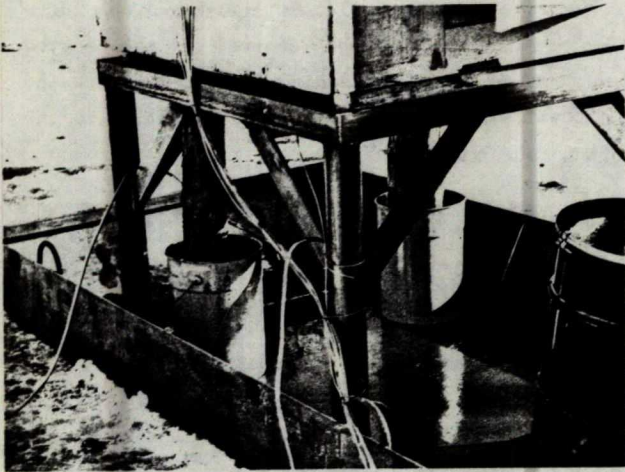
As shown in Fig. 2, the Schedule IV container was placed on a steel stand, to provide an area for the combustion material. The following items can also be seen in this figure.

- (a) On the left, the bundle of thermocouples is guided down the leg of the stand.
- (b) A steel pan was used to contain the fire and fuel oil.
- (c) Two, 20 l containers, filled with fuel oil and logs as wicks, were placed under the stand toward the back.
- (d) A 70 l drum of fuel oil with a fitted lid was placed in the pan in front of the container door.
- (e) Two copper tubes, used to feed fuel oil, can be seen on the left.

2. Container on steel stand  
(For other details refer to text)

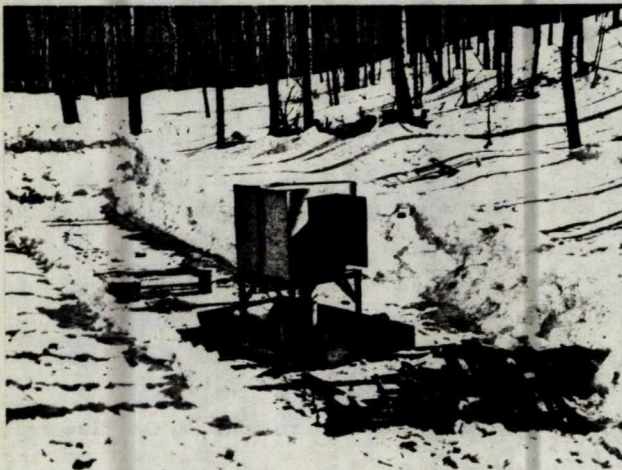
3. Container in test area

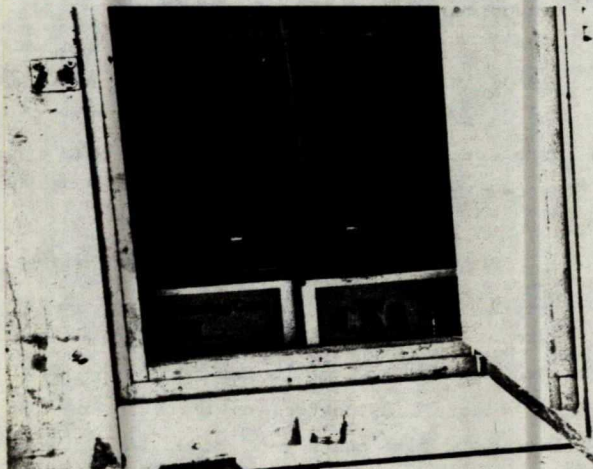
4. Box of electric detonators as placed in the container

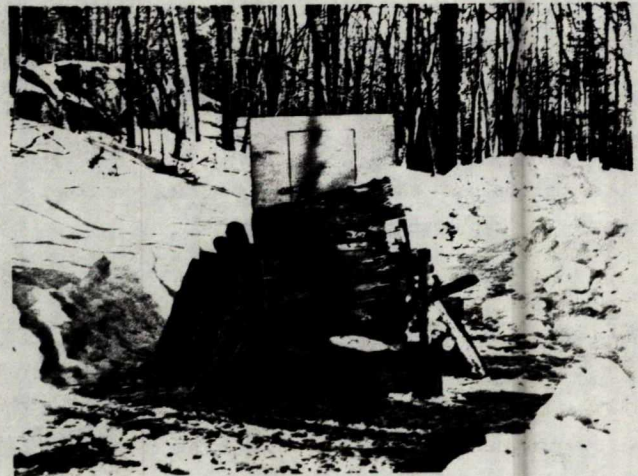
Once loaded, the door was held shut with a metal rod and wire. A cord of hardwood was then piled underneath the stand and all around the container as indicated by Fig. 5.

5. Container ready for testing
