VIDEO PROBE INSPECTION OF ROOFBOLT HOLES
AT KIDD CREEK MINE

G. Herget and B. Arjang

FEBRUARY 1989

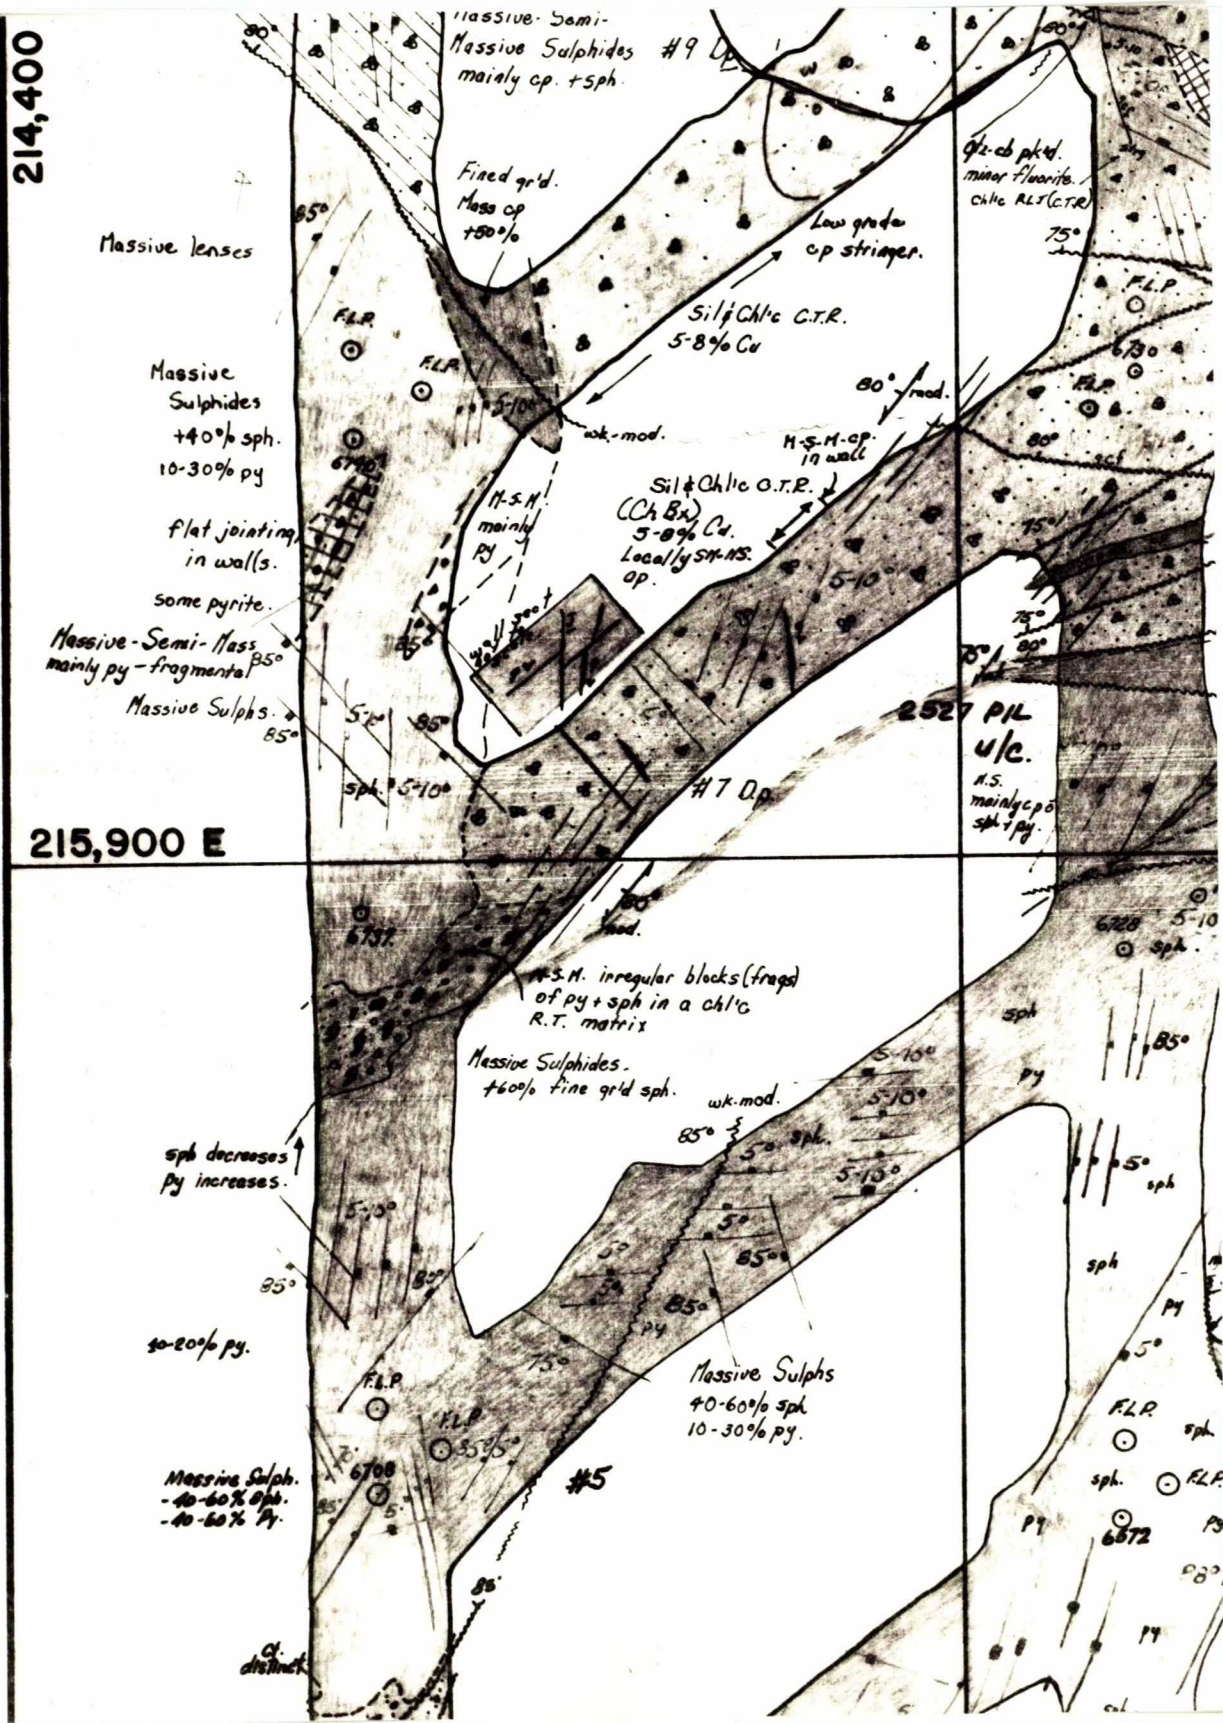
Fig. 5 - Geology of Swellex test site on 2500 level

Figure 5 shows the geology of the site provided by Kidd Creek mine. Nearly all the holes were located in massive sulfides consisting of yellow pyrite (FeS_2) and brown stringers or areas of sphalerite (ZnS). Only occasionally the holes showed quartz veins. All holes were slightly fractured at the collar from blasting. In a number of places the roof required scaling. In total the rock mass is very competent and only occasionally do the borehole walls show small breakouts from micro cracking or some subhorizontal jointing. Only seven holes showed vertical fractures (Table 1).
