**Monitoring of Interaction Effects over a Longwall
Panel in the Sydney Coalfield, Canada**

P. Cain, B. Herteis, D.A. Payne and D.J. Forrester

MRL 93-047(OP,J)

presentation at and publication in the proceedings of the
12th International Conference on Ground Control, Morgantown, W.Va.,
U.S.A., August 3-5, 1993.

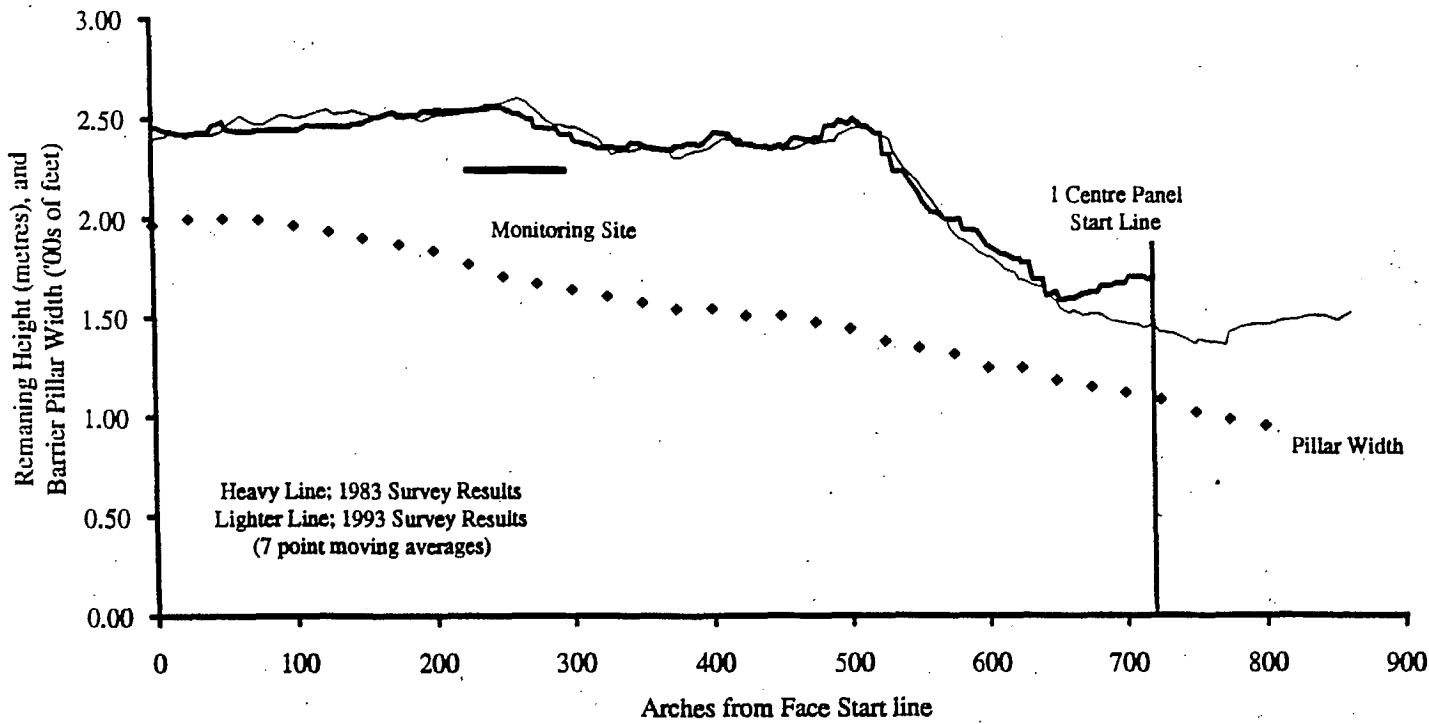
Figure 2: Gateroad deformation survey results.

A supervised inspection of the 5 East Top Level to a point well beyond the position of the 1 Centre faceline below was conducted on Friday, March 5th 1993. During the survey, gateroad heights were collected at locations coincident with the first survey in 1983, and notes taken regarding the condition of the roadway. Figure 2 compares the results of the two gateroad surveys. Time-related deformation in the ten-year interval between surveys was negligible. Major reductions in gateroad height noted in 1983 were found to be the result of floor heave, much of which had been bottom brushed in 1980/81. On re-entry into the district it was initially assumed that the floor heave was the result of the undermining of the level by the 1 Centre Face. On closer examination it was discovered that the zone of floor heave appeared to correspond with a marked reduction in the width of the rib pillar between 5 East Top Level and the adjacent 4 East Panel. The pillar width between these two panels, also shown on fig. 2, decreases from 60 m at the start of the 5 East Panel to about 35 m at the narrowest point. Little or no floor heave was observed adjacent to pillar widths greater than 40 m. The pillar width at the instrumentation site is about 50 m.

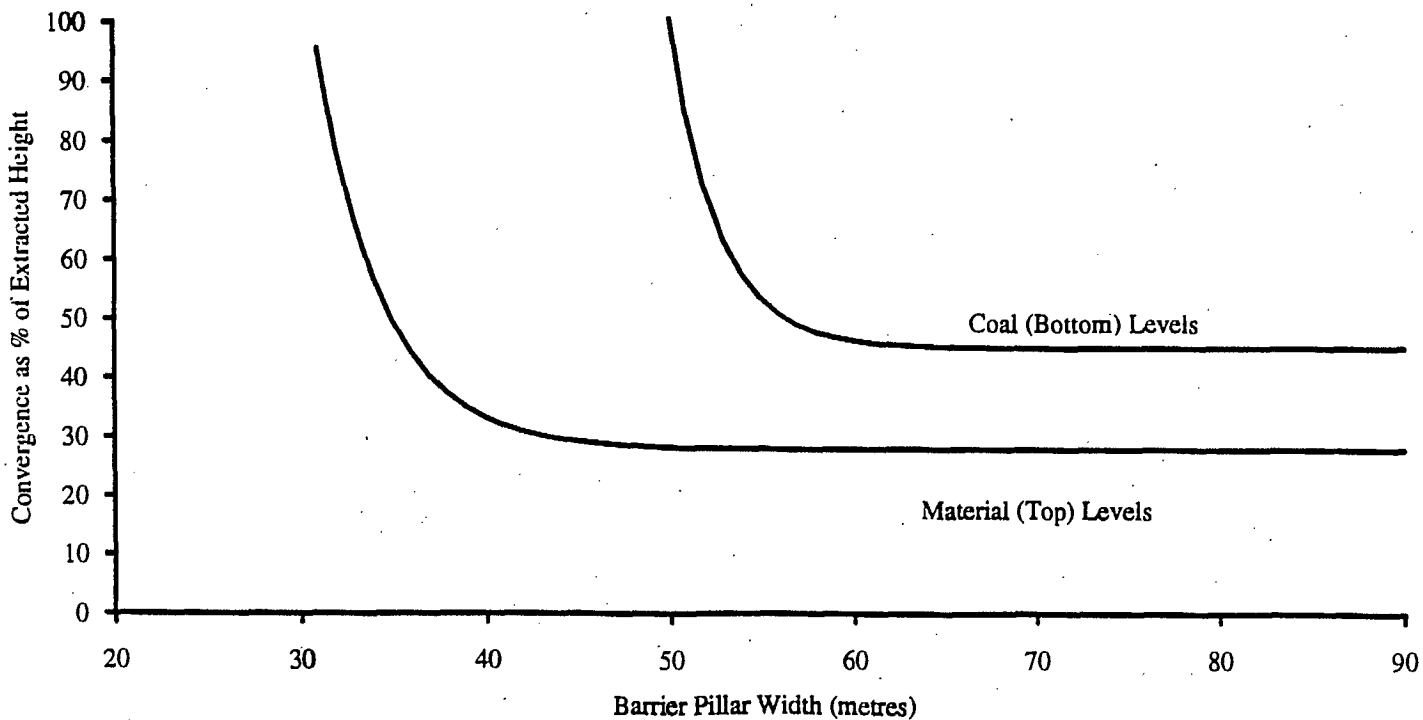
Figure 3: Development of convergence, Lingan Colliery (after (1))

Figure 3 compares vertical convergence with pillar width for material and coal roads in the Lingan Mine based on data collected during the pillar stability survey in 1983 (1). It indicates that vertical convergence increases rapidly for pillar widths less than 40 m, and that there is no decrease in

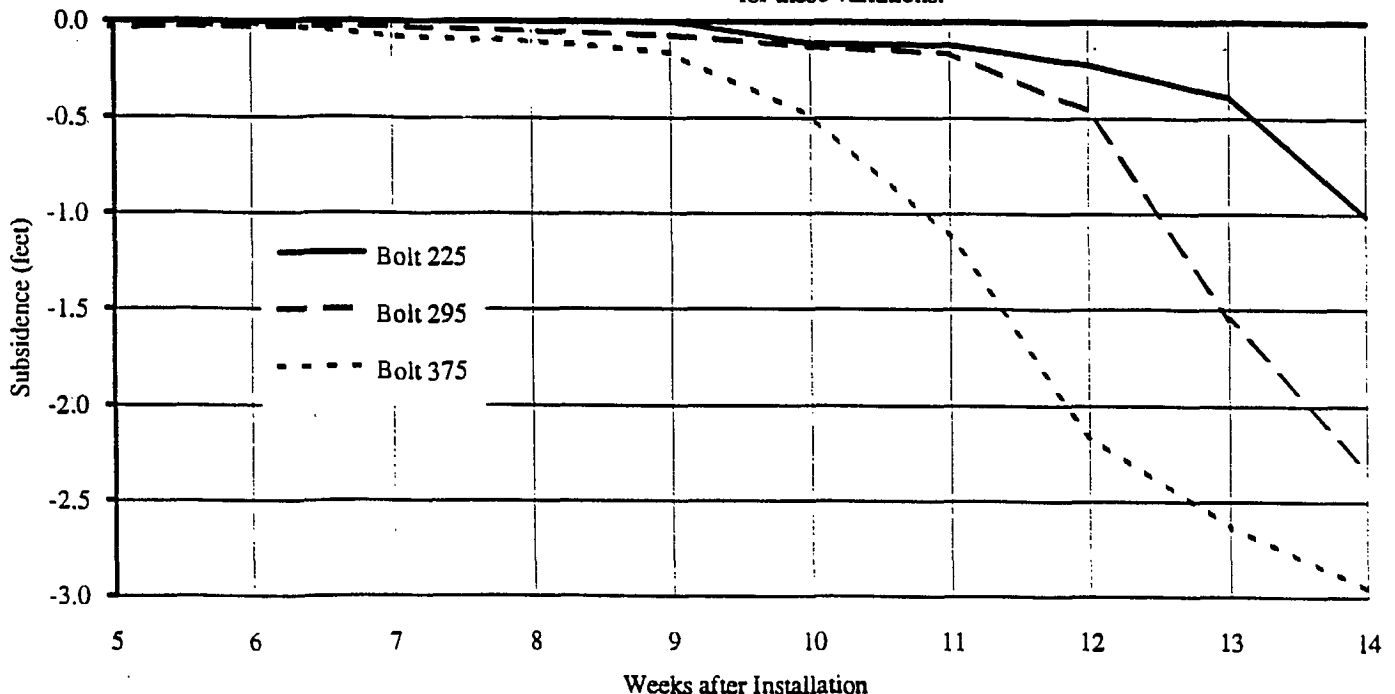
Figure 6: Development of subsidence at survey benchmarks.

As indicated above, monitoring results to date show only the first stages of the development of the traveling profile. Figure 6 shows a comparison of the results of survey leveling for three benchmarks at the inbye end of the roadway. At the time of the last survey, the coalface was beneath bolt 295. Bolt 375 is therefore about 70 m over the waste, and Bolt 225 is about 60 m in front of the faceline.

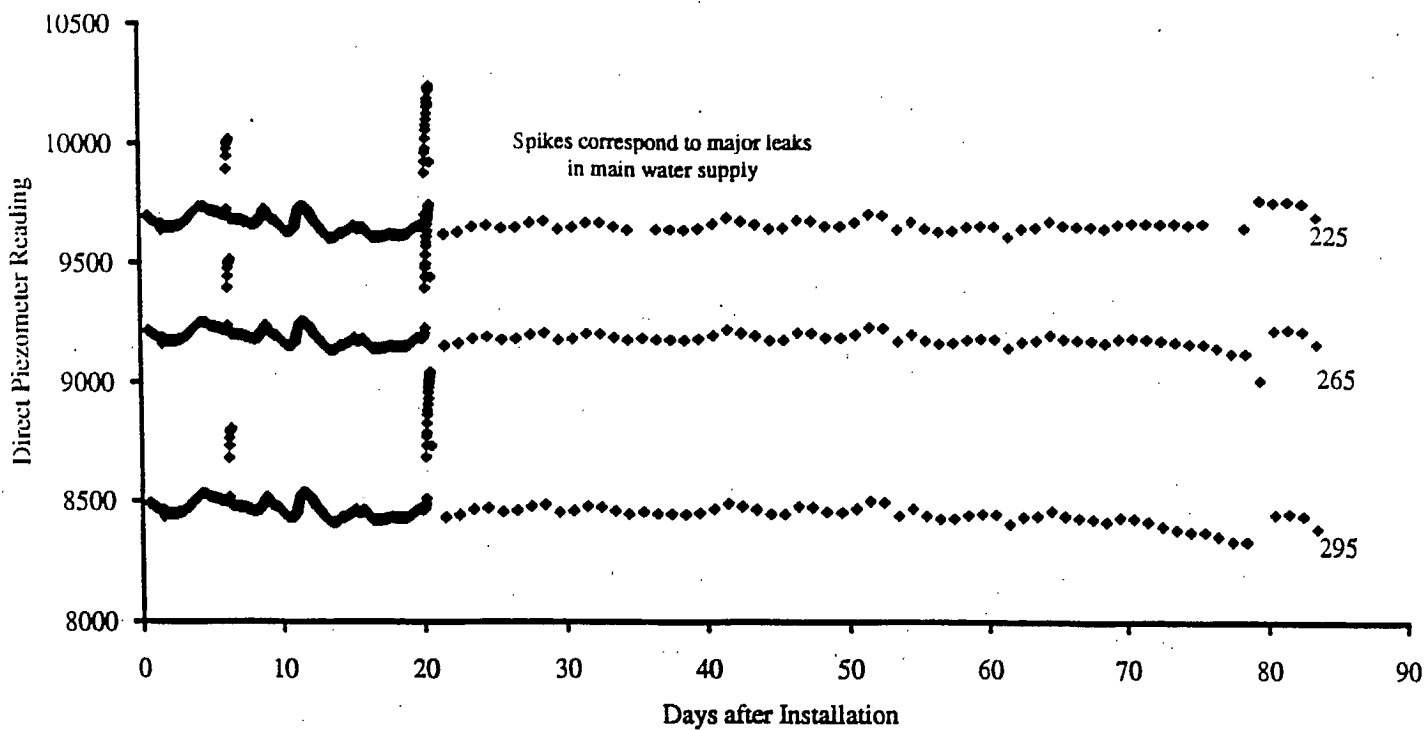
Figure 7: Data from piezometers on bolts 295, 265, and 225.

Examples of the raw data from piezometers located at the beginning (bolt 225), middle (bolt 265) and end (bolt 295) of the monitoring site are shown in fig. 7. All the recovered data is shown for the first twenty days. The remainder of the graph shows one reading per day. The response of the piezometers to the changes in barometric pressure is evident. During later analyses, data from the piezometer located in the constant head device at the remote monitoring location will be used to correct for these variations.

A general decrease in recorded frequency can be seen in the data for bolts 265 and 295, which corresponds to an increase in hydraulic head as subsidence occurs. The piezometer at bolt 225 appears unaffected by subsidence at this time. The spikes in the record correspond to periods of water loss in the main waterline due to leaks, which were subsequently repaired. The higher values obtained over the last five days or so also correspond to a partial emptying of the waterline.

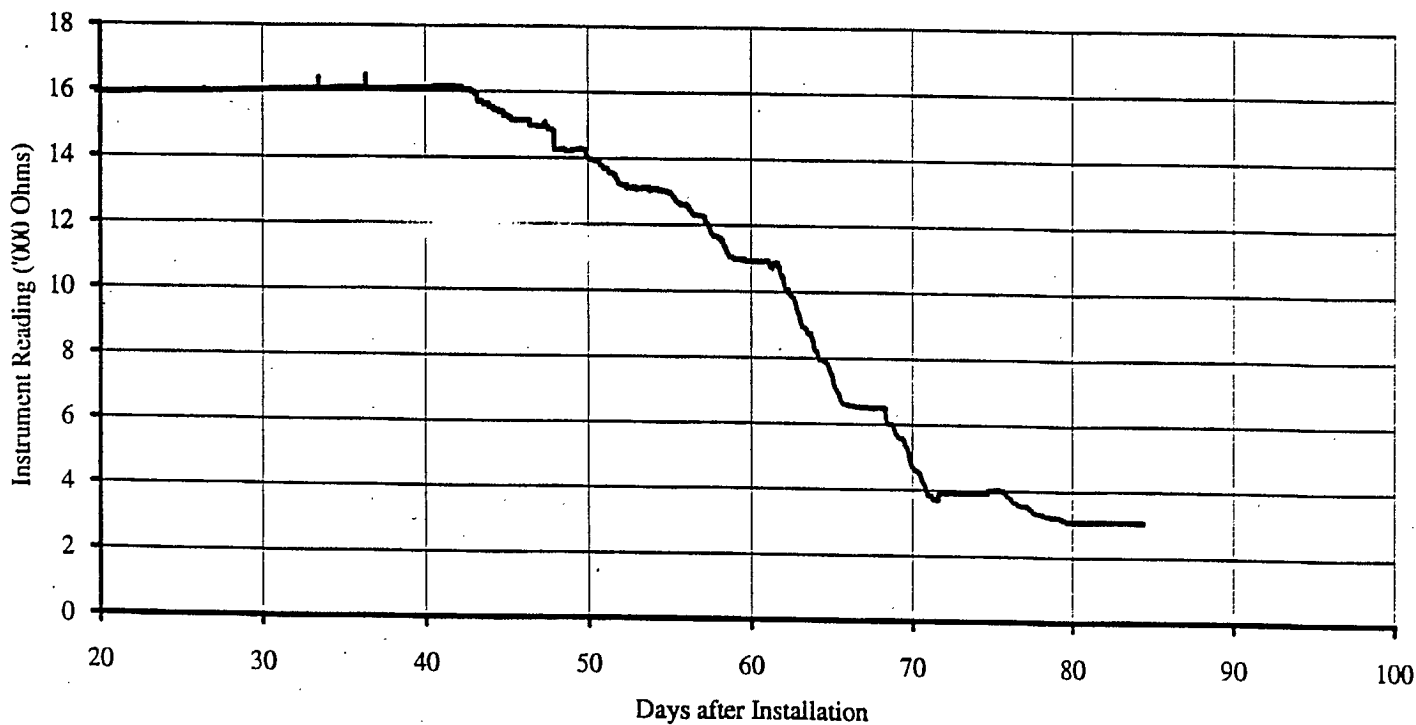
Figure 8: GMM results, bolt 290 to 295.

Raw data from the GMM extensometer between bolts 290 and 295 is illustrated in fig. 8. The reading changes as tensile strain develops in the ground between the two pins.
