REPORT

ORE DRESSING AND METALLURGICAL LABORATORIES.

Investigation No. 1512.

Examination of Four Sets of Steel Washers made to Drawings A=2314 and A=2315.

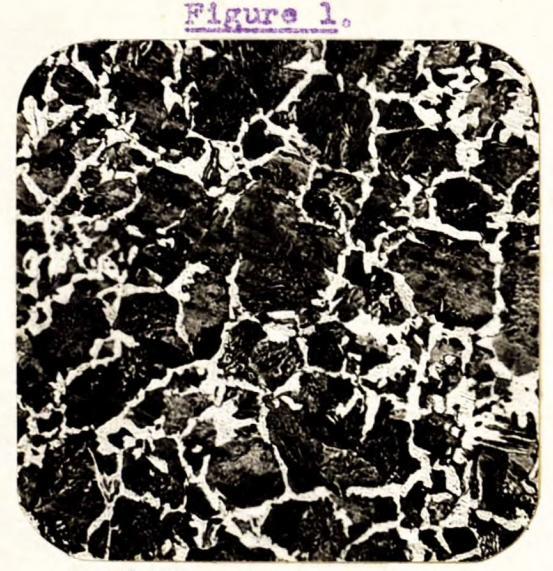
X250, nitel atch.

SHOWING THE MICROSTRUCTURE OF THE WASHERS MADE TO DRAWING A-2314. Figure 2

The four sets of washers were examined under the microscope in the unetched condition. No defect of importance was found. The specimens were then etched in 2 per cent nital solution. The structures are all ferritic and pearlitic. Washer Set No. 1 contains less free ferrite than the others (see Figure 1). Figure 2 is characteristic of the microstructure in Sets Nos. 2 and 4. Figure 3 shows the microstructure in Washer Set No. 3. Note the smaller amount of ferrite present as compared with that shown in Figure 2.

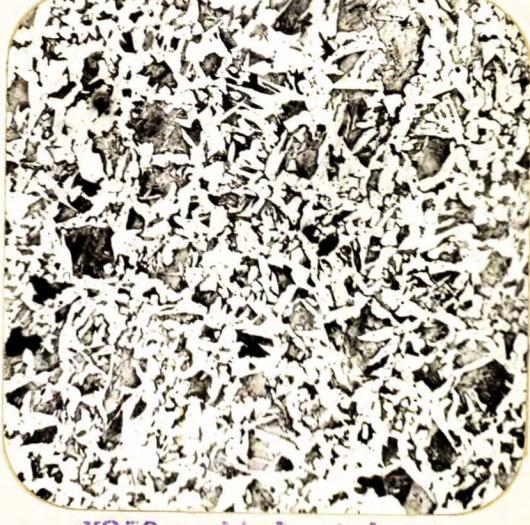
X250, mital etch.

SHOWING THE MICROSTRUCTURE OF AN UNBROKEN WASHER MADE TO DRAWING A-2315.

The microscopic examination confirmed the results of chemical analysis and hardness tests; the higher carbon and harder material containing considerably less ferrite. For the broken washers (Figure 3) the lower ferrite content as compared to the unbroken material (Figure 2) indicates fairly definitely that its carbon content is greater. The lower hardness of this material is also consistent with this assumption. It is true that, for a given carbon content, the rate of cooling may alter the amount of free ferrite. However, the nature of the ferrite found in the present case indicates that the rate of cooling is not responsible for the difference in free ferrite present.

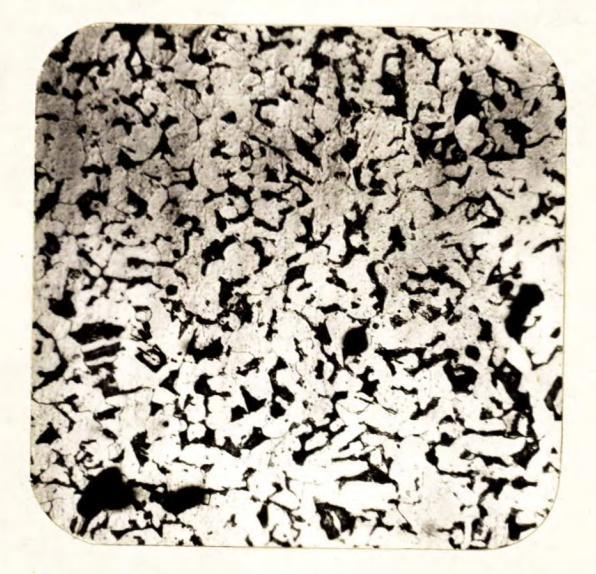
Figure 3.

X250, nital etch.

SHOWING THE MICROSTRUCTURE A BROKEN WASHER MADE TO DRAWING A-2315.

The washer failures encountered are considered to be due to the use of material of too low strength. Adoption of a higher-carbon steel, such as was found in some of the washers submitted, is recommended.
