O T T A W A August 23, 1945.

ORE DRESSING AND METALLURGICAL LABORATORIES.

Investigation No. 1922.

Metallurgical Examination of Three Austenitic Manganese Steel Samples.

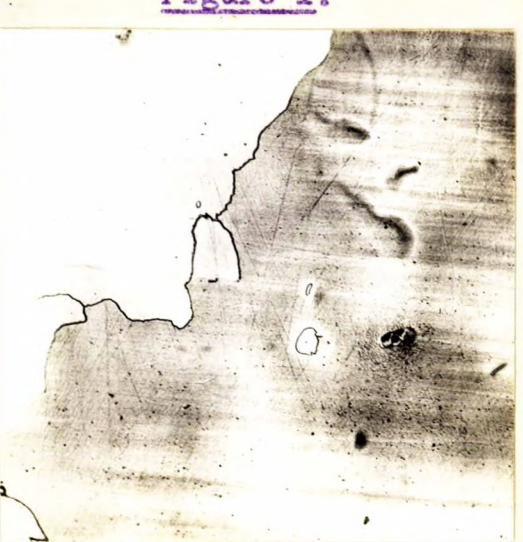
Figure 1.

The microstructures of Samples 100-1 and 100-2 were not completely austenitic but contained a mixture of austenite and cementite. Figure 1, a photomicrograph at X250 magnification, shows the microstructure of Sample 100-1. The cementite occurs as small particles within the austenite grains.

X250, etched in 2 per cent nital.

SAMPLE 100-1.

Austenite and particles of cementite.

It is claimed that the addition of from 1 to 3 per cent of chromium reduces the amount of cold work necessary to properly harden austenitic manganese steels. The fact that Samples 100-1 and 100-2 have a significant chromium content is a plausible explanation for their unusally good service.

It is, moreover, a well-known fact that the presence of small carbide particles in a softer matrix will produce remarkable wearing properties in a steel. It is therefore notable that these two ball mill liners have such a microstructure, with particles of iron-manganese carbide in an austenitic matrix. This structure gives better wear resistence than a completely austenitic structure if the operating (Discussion, contid) -

<u>1.</u> Samples 100-1 and 100-2, reported to have given record-breaking service as ball mill liners, are characterized by relatively high chromium contents. The heat treatment given these parts <u>has not</u> produced a completely austenitic microstructure.

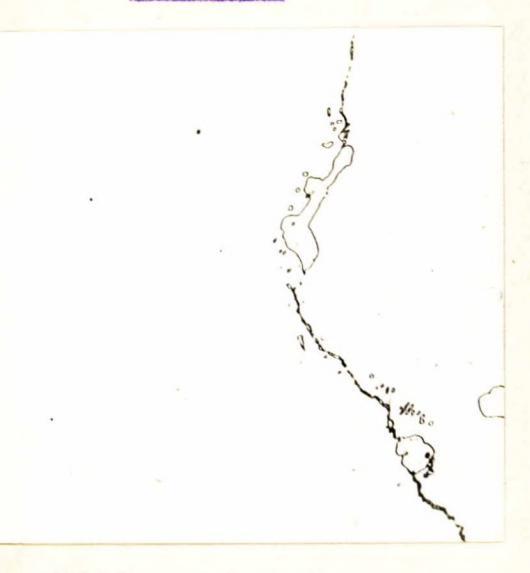
Figure 2.

The microstructure of Sample 100-2 contained more cementite than that of Sample 100-1; also, the greater proportion tion of the cementite is found at the austenite grain boundaries rather than within the grains. See Figure 2, a photomicrograph at X250 magnification.

X250, etched in 2 per cent nital.

SAMPLE 100-2.

Austenite with relatively large particles of comentite located at an austenite grain boundary.

conditions do not involve any cold work to the metal, but it does so at the expense of ductility, particularly when the carbide particles are located at the grain boundaries. From the record of these ball mill liners, it would appear that for such parts full ductility is not required and therefore the properties of Castings 100-1 and 100-2 were particularly well suited to their uses.

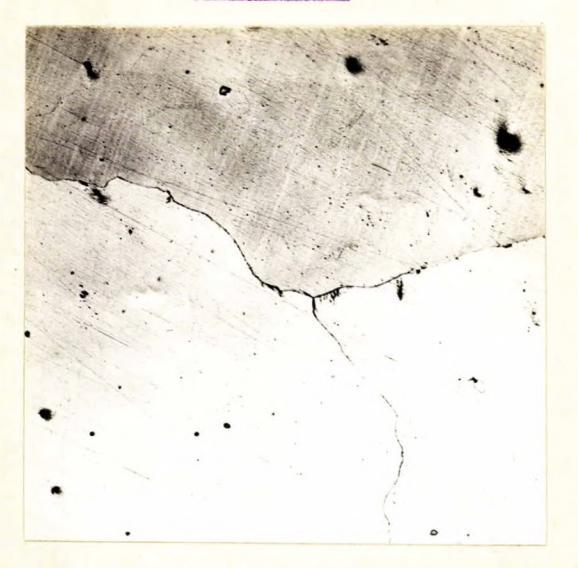
Figure 3.

The microstructure of Sample 100-B consists of large-grained austenite (see Figure 3, a photomicrograph at X100 magnification).

X100, stched in 2 per cent nital.

SAMPLE 100-B.

Completely austenitic microstructure, of large grain size.

There is no apparent reason for the unsatisfactory behaviour of the Symons crusher mantle, other than that the service stresses imposed have exceeded the yield strength of a properly heat-treated casting of this composition. The yield strength of austenitic manganese steels is always low in proportion to the tensile strength, i.e., for a tensile strength of approximately 125,000 p.s.i. the yield strength would be about 35,000 p.s.i.

Microscopic examination has shown that the heat treatment of Casting 100-B was satisfactory and has produced a completely austenitic casting, which is considered the optimum condition for parts such as crusher mantles which must have considerable toughness as well as resistance to abrasive wear. The grain size of this casting is unusually large but, although this would likely reduce the impact strength, it is not known to cause low yield values. Assuming, then, that the casting in its optimum condition has not given satisfactory service, there is only one way, other than increasing the size of the section, to improve this condition and that is by a change in the chemical composition. It is generally agreed that silicon up to a limiting critical value is very valuable in increasing the yield strength and resistance to flow without substantial sacrifice of toughness. Some manufacturers claim that the addition of moderate amounts of

2. Sample 100-B has a completely austenitic microstructure of relatively large grain size. It is suggested that the cause of failure might be determined by comparing the chemical composition of this with more satisfactory cone crusher mantles.
