INTRODUCTION

This project addresses knowledge gaps related to permafrost conditions, landslides, and earthquake hazards along a potential pipeline route within the Alaska Highway Corridor in the Yukon Territory (YAHC). Essential and critical baseline geoscience information and knowledge is being generated, and techniques and models developed to support a) pipeline design, b) environmental assessment and regulatory processes, and c) development of environmental monitoring and management programs to ensure environmental effects are minimized. Reconnaissance fieldwork was carried out in summers 2011-12 in the study area (Fig. 1). The objectives of this poster presentation are to show results from 1) Permafrost characterization, 2) Landslide distribution, 3) Qualitative landslide susceptibility mapping in permafrost terrain, and 4) Denali fault investigations.

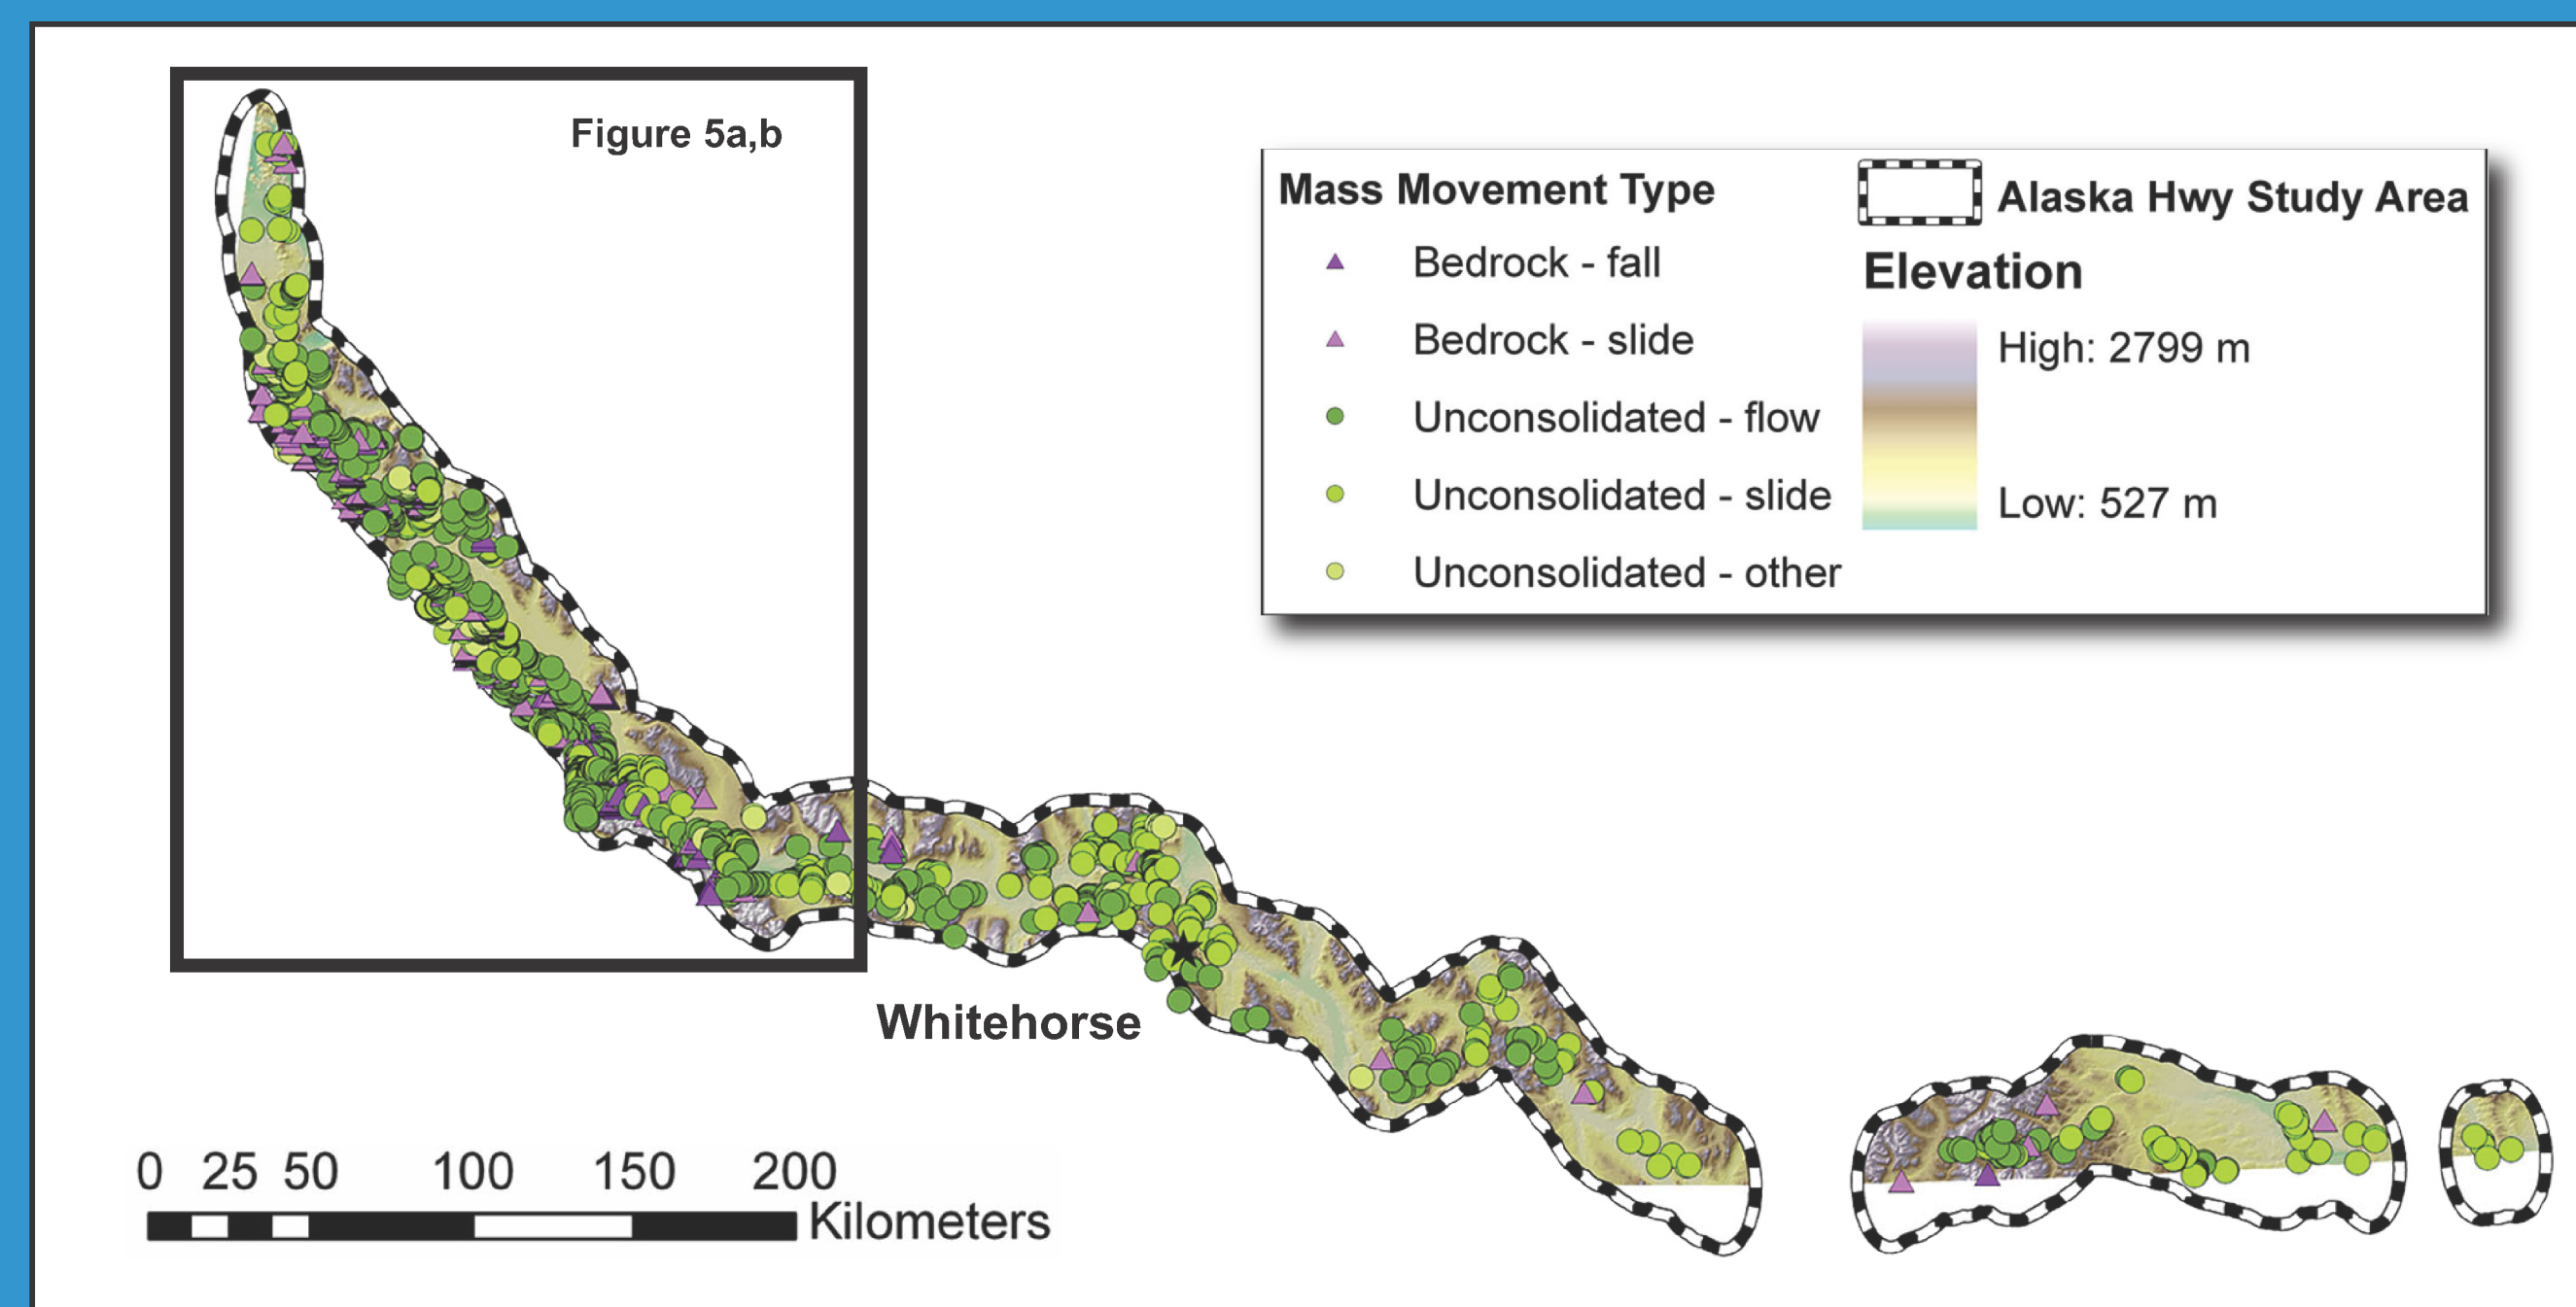
Figure 3. Map of landslide distribution displaying landslides triggered in bedrock (purple triangles) and those triggered in sediment (green circles). A total of 1743 landslides were identified. Black star indicates location of Whitehorse. Rectangle indicates location of Figures 5a and b.

Landslides were identified and compiled from air-photo interpretation. Fifty-one inventory maps were produced at the 1:50,000 scale (Blais-Stevens et al., 2011a) as well as a landslide distribution map (Fig. 3). All data products are publicly available. In addition, high resolution satellite imagery is being investigated as a method to update and improve the landslide inventory.

The main landslide types from the inventory were: debris flows and slides, earth slides/flows, rock slides, rock falls, retrogressive thaw flows and active layer detachments. Landslide distribution reflects dominant landslide activity in unconsolidated sediments (Fig. 3). The use of recent high resolution satellite imagery is currently being assessed to update the landslide inventory.
